# Analysis of Alarm in Near Field Monitor ILS Thales 421 at AirNav Semarang Branch

Elizabeth Rindi Novitri<sup>1</sup>, Eriyandi<sup>2</sup>

<sup>1,2</sup>Telecommunication and Navigation Engineering  
Indonesia Civil Aviation Polytechnic  
Tangerang, Indonesia  
16032110010@ppicurug.ac.id

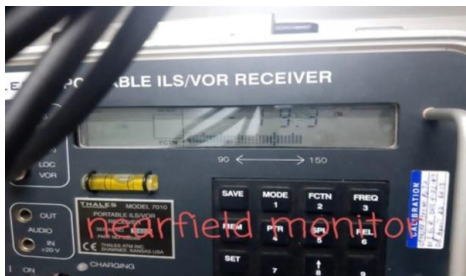
Fig. 5 Results of PIR Measurement on Nearfield Input Cable

2. Then, the technician measures the RF Level on the Nearfield input cable located above the Localizer equipment rack using the PIR. The measurement yields a result of -42.5 dB. This result indicates signal attenuation, as the previous measurement showed a result of -19.3 dB.

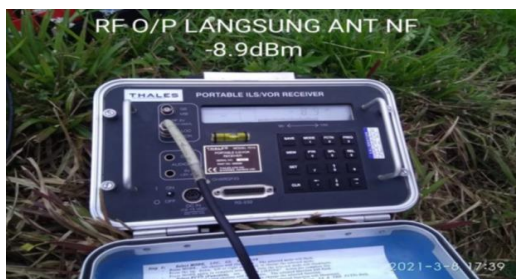
Fig. 6 Results of PIR Measurement on Nearfield Antenna

3. Next, the technician measures the RF Level at the panel box behind the Localizer shelter and the Nearfield antenna using the PIR. The measurement yields a result of -8.9 dB from the Nearfield antenna.

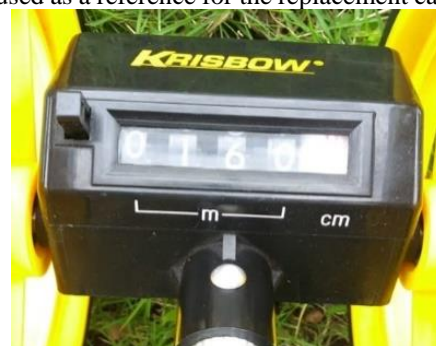
Fig. 7 Results of Cable Length Measurement

d. In the field, the results from the check using the Avometer showed the outcome as in point c number two: when the short at one end of the cable was removed, the buzzer continued to sound, indicating that the cable is in a short condition. Therefore, it is necessary to replace the cable due to the old cable's condition, which is no longer suitable for use.

After investigation, it was found that the cable from the nearfield antenna to the panel box behind the localizer shelter was experiencing a short. Therefore, the technician addressed the issue with the following steps:

- Before replacing the cable, the technician measured the length of the cable from the nearfield antenna to the panel box behind the localizer shelter using a surveyor's wheel. From this measurement, a length of approximately ±160 meters was obtained, which will be used as a reference for the replacement cable length.

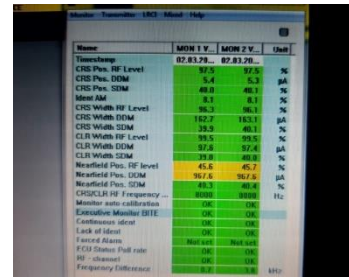
Fig. 11 Values on Monitor Before Calibration and Normalization

6. After connecting the cables, the technician rechecks the monitor to ensure that values are now displayed on the monitor, which previously showed a value of 0.

7. The values on the monitor have reappeared but are still not correct. Following the guidelines in the Localizer THALES 420 manual Part 1, page 5-15, the technician perform calibration and normalization on the control monitor in the Localizer shelter to adjust the reference parameters entered. The steps taken are as follows:
