## Application of the Revegetation Sheet with the Erosion Control Function to the Expansive Clay Soil Slope

### -A Case Study on Test Construction and Monitoring in West Java, Indonesia-

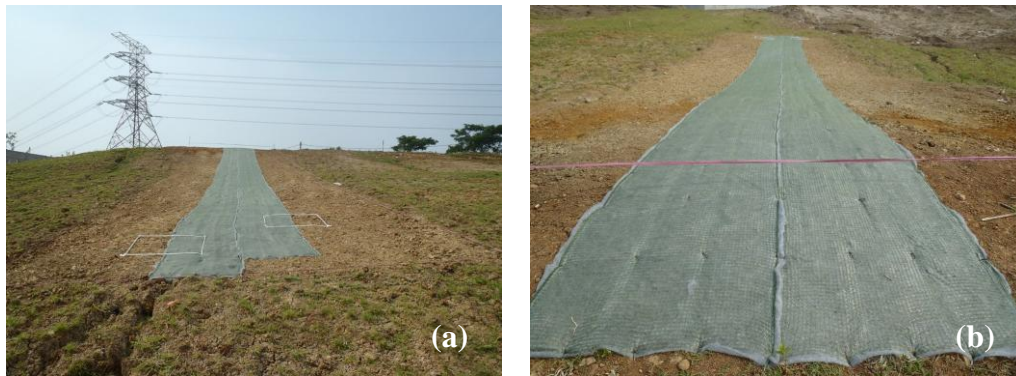
**Figure 1. Construction condition at A site (Acryl type sheet: 50m<sup>2</sup>, 20<sup>th</sup>, February, 2014)**

(a) Full view from the front lower part just after construction (b) Full view from the front upper part just after construction

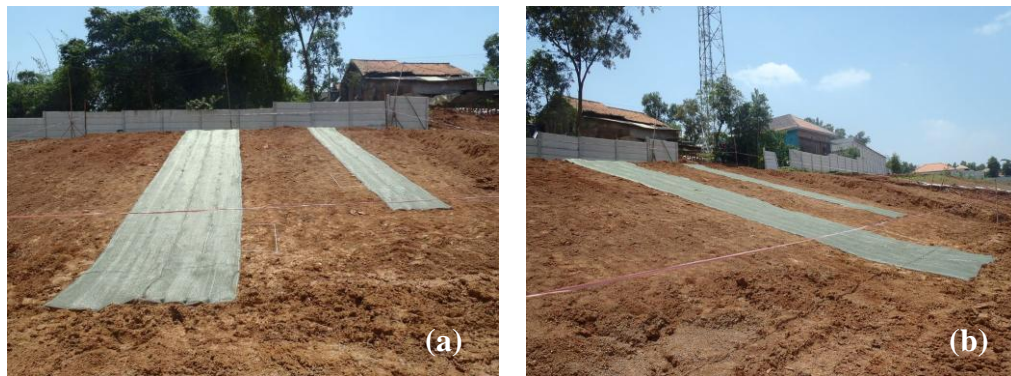
**Figure 2. Construction condition at B site (Polyester type sheet: 50m<sup>2</sup>, 20<sup>th</sup>, February, 2014)**

(a) Full view from the front lower part just after construction (b) Full view from the left slant lower part just after construction

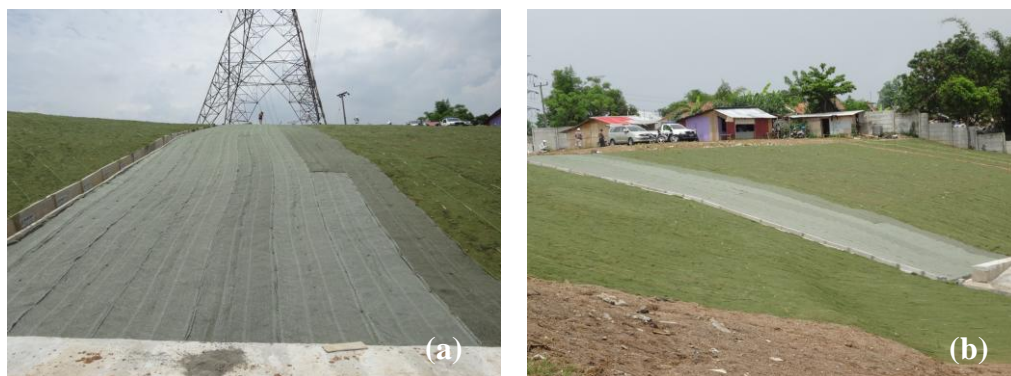
**Figure 3. Construction condition at C site (Polyester type sheet: 190m<sup>2</sup>, 5<sup>th</sup>, December, 2014)**

(a) Full view from the front lower part just after construction (b) Full view from the left slant part just after construction

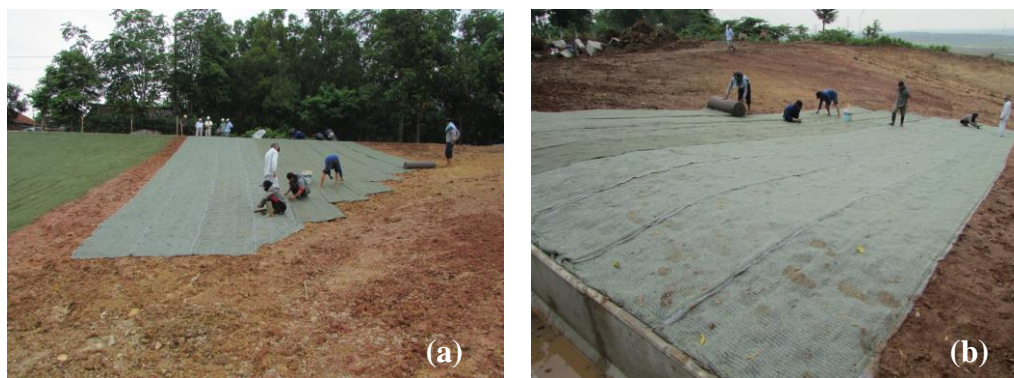
**Figure 4. Construction condition at D site (Polyester type sheet: 300m<sup>2</sup>, 14<sup>th</sup>, January, 2015)**

(a) Full view from the front lower part under construction (b) Full view from the front upper part under construction

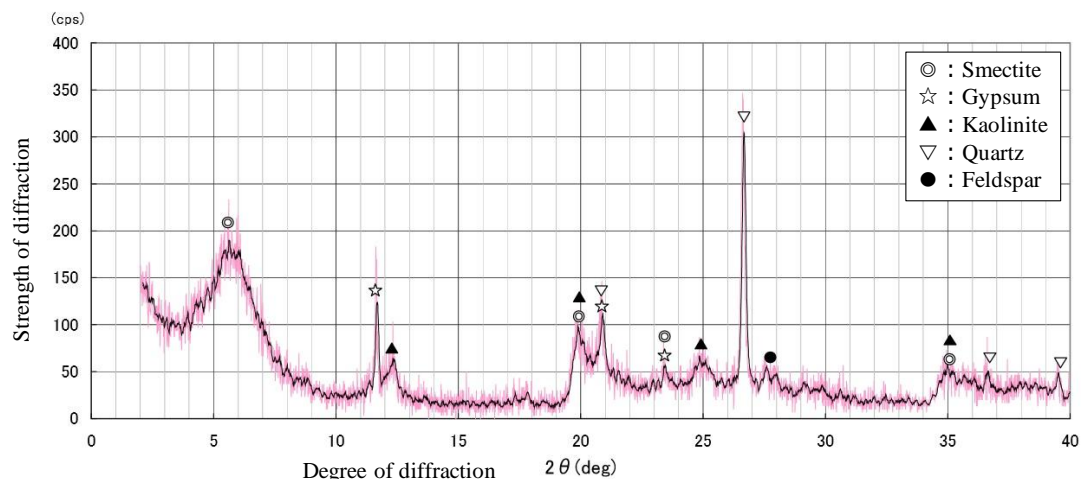
**Figure 5. Whole rock approach of the soil in the lower part of the slope in A site using X-ray powder diffraction**

By the whole rock approach using the X-ray diffraction, a large amount of smectite and quartz, a small amount of gypsum and a very small amount of feldspar and kaolinite were detected respectively (Figure 5.). While, by the clay fraction approach, kaolinite, smectite and illite were detected and especially the peak of smectite was significantly high (data not shown). In the site near GIIC, smectite, quartz and kaolinite were detected as a result of the whole rock approach using X-ray diffraction (Kumitsu and Katakami, 2013). The result indicated the similar one this time, so that it was considered that the soil has a large amount of smectite and quartz and a small amount of gypsum, feldspar and kaolinite. Actually, the

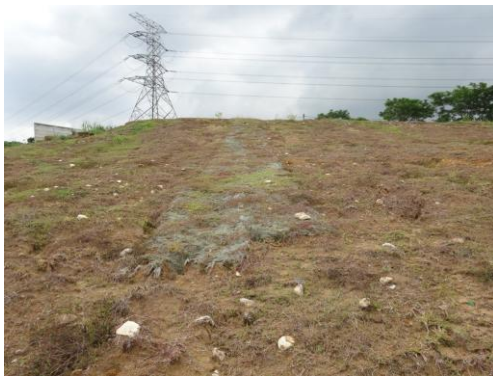
**Figure 6. Whole view after 13 months**

After 13 months, the disappearance of the protection net by the partial deterioration and the trample of cow in some parts were observed, but the fine fibers of non-woven fabric adhered to the soil surface firmly. Although the bare soil, on which the sheet had not been covered, in both sides of the sheet was eroded considerably (Figure 6 and 7),

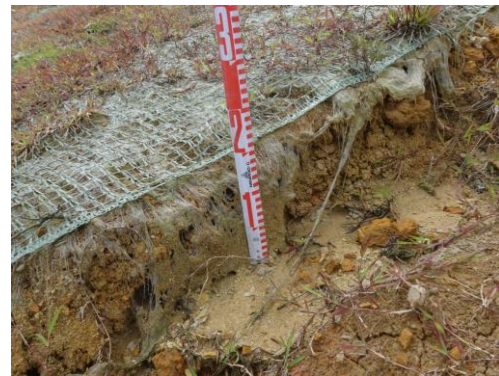
**Figure 7. Level difference in the border line between the sheet covered plot and the neighbor bare plot after 13 months**

the traces of soil erosion beneath the sheet were not observed, so that it was demonstrated that the sheet had prevented the soil erosion remarkably. After 2 months, the level difference in the border line between the sheet covered plot and the neighbor bare plot had been 5 to 10cm, but it increased to 18cm at most after 13

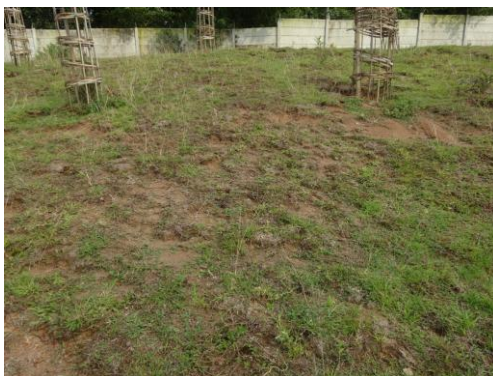
**Figure 8. Whole view from the front after 13 months**

In the site, the sodding was applied after covering with the sheet. Therefore, the sheet was not observed and the only vegetation remained (Figure 8). While, in the bare plot of the surrounding of the site, much gully erosion occurred (Figure 9).

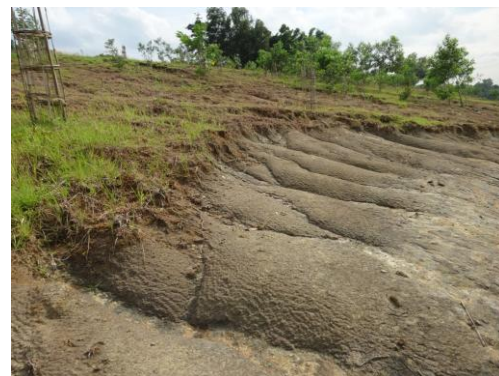
**Figure 9. Appearance of the gully erosion occurred in the bare plot of the surrounding of the site**

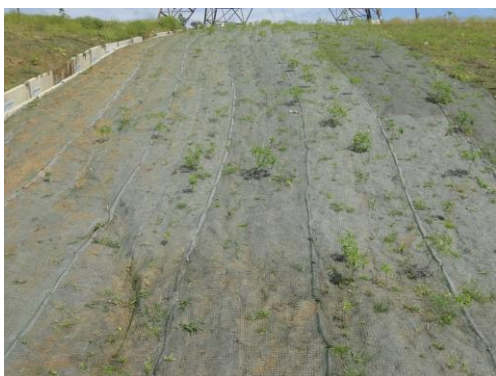
**Figure 10. Whole view from the front after 3 months**

After 3 months, the sheet prevented the soil erosion for the rainfall in rainy season on the whole (Figure 10). In the border line between the sheet covered plot and another similar sheet covered plot, the level difference of 4cm at most was observed (Figure 11). Average level difference values of three points inside the quadrat in the upper and the lower parts of the slope were 1.7cm and 2.3cm respectively, thus the latter was slightly higher than the former. The

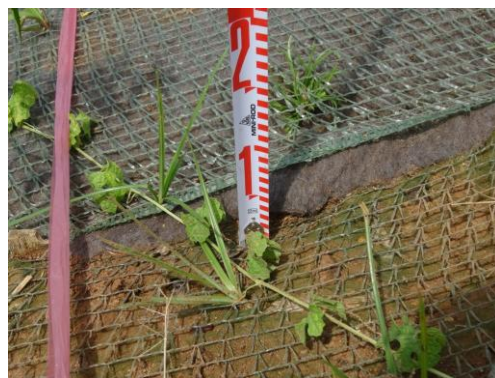
**Figure 11. Level difference in the border line between the sheet plot and another similar sheet plot after 3 months**

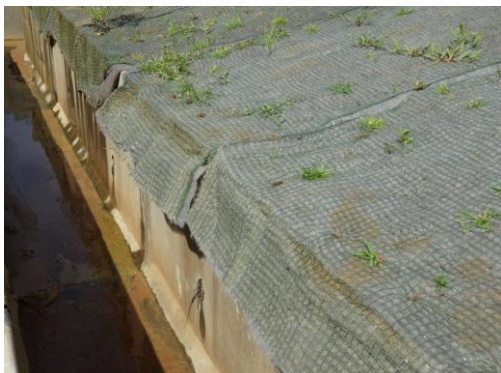
**Figure 12. Condition in the drainage channel under the sheet covered plot after 3 months**

In another similar sheet covered plot, the sheet and many bamboo skewers were run off by the rainfall and the soil was bared, so that the numerous traces of soil erosion by the raindrop impact were observed. The runoff of soil into the drainage channel under the new type sheet covered plot scarcely occurred (Figure 12), but under another similar sheet covered plot, the soil was run off by rainfall and accumulated in the drainage channel (Figure13).

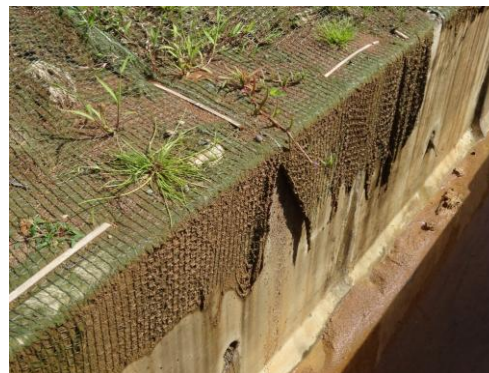
**Figure 13. Condition in the drainage channel under another similar sheet covered plot after 3 months**

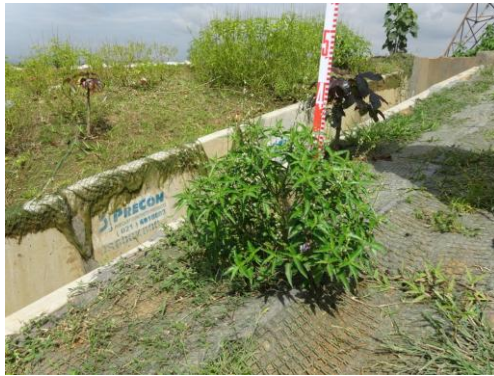
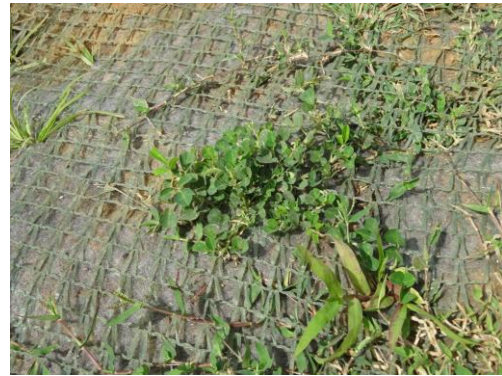
**Figure 14. Condition of vegetation in the sheet covered plot after 3 months**

**Figure 15. Condition of the growth of creeping plants in the sheet covered plot after 3 months**

In the new type sheet covered plot, the vegetation recovered (Figure 14 and 15) and the vegetation rates in the upper and the lower parts were 10% and 5% respectively. While, in another similar sheet covered plot, the vegetation rates in the upper and the lower parts were 30% and 5% respectively. It was considered that the recovery of vegetation had delayed in the new type sheet covered plot because it was covered after another similar sheet had been removed and the slope had been prepared again.

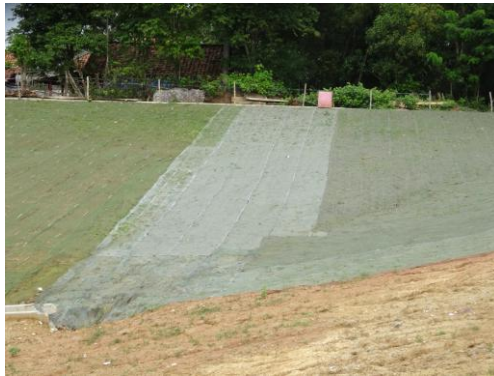
**Figure 16. Whole view after 2 months**

After two months, the sheet prevented the soil erosion for rainfall in rainy season on the whole (Figure 16). The conspicuous damage of the sheet and the gully erosion in soil beneath the new type sheet were not seen. While, in the bare part where the sheet had not been covered, the soil surface was run off and many gully erosions occurred (Figure 16). Level differences in the border line between the new type sheet covered plot and the neighbor bare plot in the upper and lower parts of slope were 6.0cm and 11.0cm respectively, so that the latter was

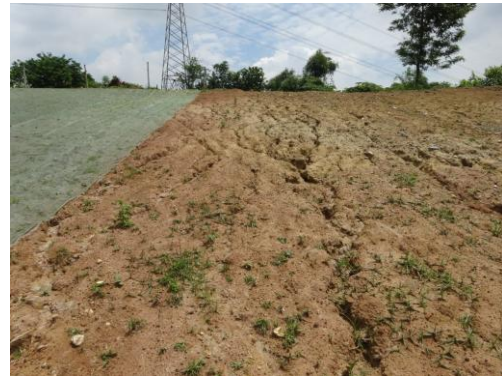
**Figure 17. Appearance of the gully erosion occurred in the bare part of the neighbor of the sheet covered plot**

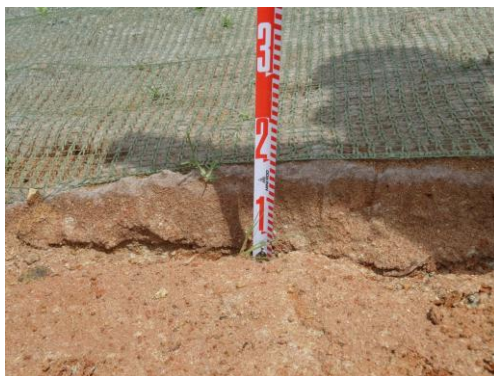
**Figure 18. Level difference in the border line between the sheet covered plot and the neighbor bare plot after 2 months**

bigger than the former because the latter was steeper than the former (Figure 18). In another similar sheet covered plot, the non-woven fabric and many bamboo skewers were run off

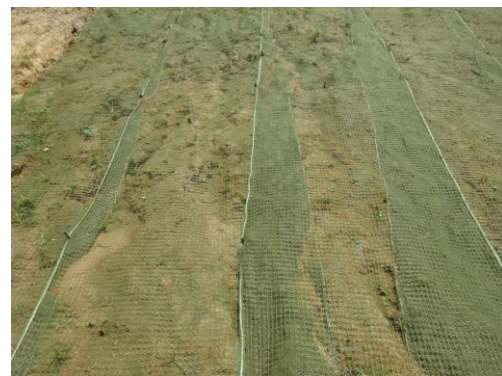
**Figure 19. Appearance of soil erosion beneath another similar sheet after 2 months**

and the soil surface was bared and the soil which had been run off by rainfall was accumulated in the under part of slope as well as in C site (Figure 19).

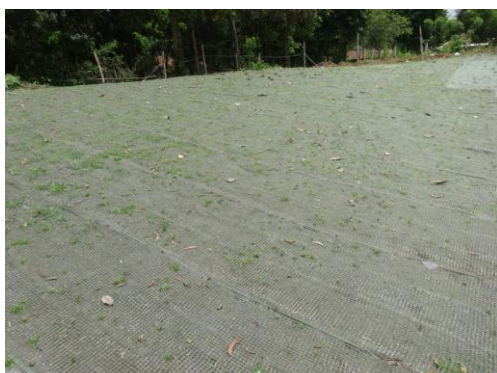
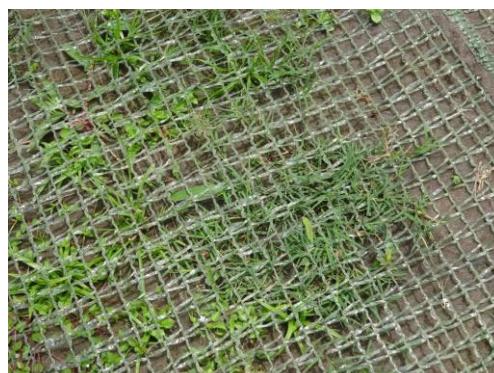
**Figure 20. Distant view of vegetation in the sheet covered plot after 2 months**

**Figure 21. Close-range view of vegetation in the sheet covered plot after 2 months**

In the bare plot, the vegetation rate was 10%, but the vegetation rates in the upper and the lower parts of slope covered with both the new type sheet and another similar sheet were 20% and 5% respectively (Figure 20 and 21). From the result, it was considered that the invading plants of the flied and buried seeds had established and grown easily in the upper part of slope.
