# Analysis of Alarm in Near Field Monitor ILS Thales 421 at AirNav Semarang Branch

Elizabeth Rindi Novitri<sup>1</sup>, Eriyandi<sup>2</sup>

<sup>1,2</sup>Telecommunication and Navigation Engineering  
Indonesia Civil Aviation Polytechnic  
Tangerang, Indonesia  
16032110010@ppicurug.ac.id

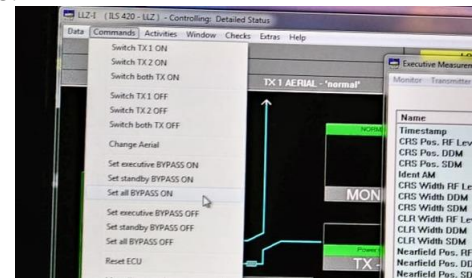
Fig. 12 Display on ADRACS Windows

7. The values on the monitor have reappeared but are still not correct. Following the guidelines in the Localizer THALES 420 manual Part 1, page 5-15, the technician perform calibration and normalization on the control monitor in the Localizer shelter to adjust the reference parameters entered. The steps taken are as follows:

- a. Configure the equipment to "bypass" mode to prevent it from shutting down by selecting the "Commands" menu in the top left corner and then choosing "Set all BYPASS ON" on the remote PC.

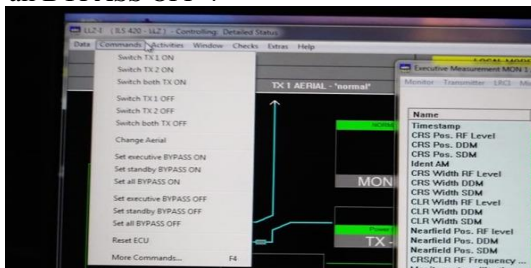
Fig. 17 Display on ADRACS Windows

- 8. After calibration and normalization have been completed, the red indicator (alarm) on the Nearfield Position monitor has changed back to green (normal). This indicates that the readings on the Nearfield Position monitor are now operating normally again.

- f. Turn off the bypass by clicking the “Commands” menu in the top left corner and then selecting “Set all BYPASS OFF”.
