ANALYSIS OF HYGIENE AND SANITATION IN CHICKEN SLAUGHTERHOUSES IN JAMPANG VILLAGE, BOGOR REGENCY, WEST JAVA PROVINCE, INDONESIA

Keywords: Hygiene, Sanitation, Chicken Slaughtering House

The purpose of study is to evaluate the implementation of hygiene and sanitation of chicken slaughterhouses.

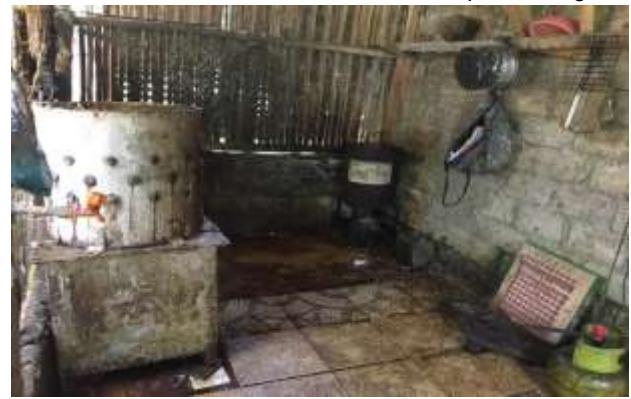
Table 6 shows the results of the building construction assessment where the layout is not in line with the flow of the chicken slaughtering production process due to the insufficient space, so most of the slaughtering processes are carried out close to one another. There is no clear physical separation between clean and dirty areas. The wall is not made of waterproof and corrosive material. The floor is not made of materials that are not waterproof, slippery, corrosive, and not perforated. The roof of the building is watertight and has no holes. The building construction has not been designed to be rodent free. Good ventilation is more than 10% of floor area. Buildings have not been cleaned and disinfected regularly every 2 weeks.

According to SNI 01-6160-1999, the layout must be designed so that it is in line with the process flow and has sufficient space so that all poultry slaughtering activities can run well and hygienically. The size of the room must also be adjusted to the cutting capacity. There are no clear boundaries between dirty and clean areas. So that workers are free to enter clean and dirty areas. This will cause cross-contamination through the skin, rumen fluids, blood, and labor of the carcass. So that the carcass produced and marketed becomes unsafe and unhealthy for consumption (Rohyati, 2017). A picture of the production room of a chicken slaughterhouse in Jampang Village can be seen in Figure 1. The chicken slaughterhouse building does not meet the requirements for walls and floors, as can be seen in Figure 1. This requirement is not fulfilled, among others, because there is a wall made of brick which is only roughened, without any more layers so that the material is not waterproof and has the potential to grow moss around the walls.

Figure 1. Construction of Chicken Slaughterhouses in Jampang Village

Proposed improvements to the Chicken Slaughterhouse in Jampan Village based on SNI 01-6160-1999 include: routine health checks, standard equipment must be met, sanitary buildings made separate from living quarters. In addition, spatial planning is improved in the direction of the process flow, there is a clear physical separation between clean and dirty areas. Walls and floors in buildings must be designed to be waterproof, not easily corrosive. The building construction is made rodent-free and disinfected every two maintain cleanliness. The weeks to completeness of the building must have an employee rest area, a place for storing personal items, and generating sets. Sanitation facilities must be fulfilled, one of which is a means of washing hands and providing soap, a cloth / hand drier as a hand dryer. Carcass tools can be replaced with tools made from stainless steel. The carcass must also be cleaned using detergent every day. The chicken coop should be cleaned and washed regularly. The carcass is placed on a waterproof mat and not the cutting floor, the chicken carcass should be temporarily stored in a closed container after which it is burned.

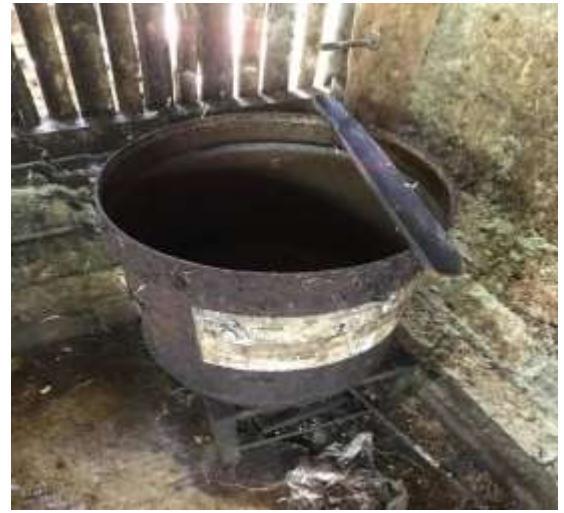
Table 12 shows that the pot utensils used are corroded. The pot that is used is washed every day. Pans used but never washed using detergent. This condition can cause microbes to contaminate broiler chickens such as salomonella (Aerita *et al.*, 2014). The pan equipment used can be seen in Figure 2. INTERNATIONAL JOURNAL OF BIOSCIENCES AND BIOTECHNOLOGY · Vol. 8 No. 2 · April 2021 eISSN: 2655-9994 pISSN: 2303-3371

Figure 2. Equipment for a Chicken Slaughterhouse Dipping Pot in Jampang Village

According to SNI 01-6160-1999, equipment that is directly related to meat must be made of non-toxic, non-corrosive, easy to clean and densified and easy to care for.

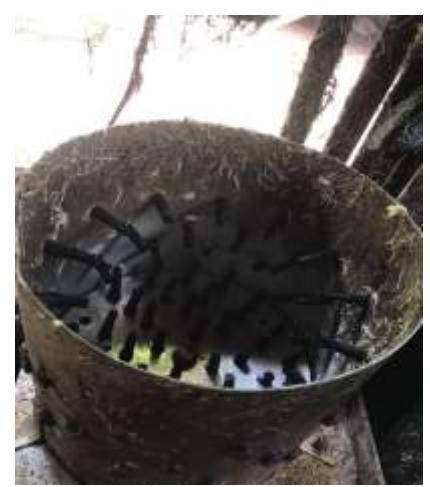
Table 13 shows that the hair removal tool used is corroded but is washed daily without using detergent. The hair removal tool used in chicken slaughterhouses can be seen in Figure 3.

Figure 3. Feather removal tool for a chicken slaughterhouse in Jampang village
