ANALYSIS OF HYGIENE AND SANITATION IN CHICKEN SLAUGHTERHOUSES IN JAMPANG VILLAGE, BOGOR REGENCY, WEST JAVA PROVINCE, INDONESIA

This chicken slaughterhouse in Jampang Village, Bogor Regency, West Java, Province, Indonesia is a home industry that is engaged in chicken slaughter. The problem in this research is the process of slaughtering chickens that do not meet the standards. The purpose of this study was to identify the hygiene and sanitation of chicken slaughterhouses. Data collection was done by filling out questionnaires and observations. The observation sheet is made based on SNI-01-6160-1999 concerning Poultry Slaughterhouses. The observation sheet was used to assess the hygiene and sanitation conditions using the scoring method. This study used descriptive statistics to analyze the observed data. The scoring method is done by determining the weight for each variable and determining the value for each of the assessed aspects. The results showed that the workers were in good health. Not yet using boots, masks, aprons and headgear. The building is still integrated with the residence. The layout is not in line with the flow of the production process. Sewerage drain is readily a

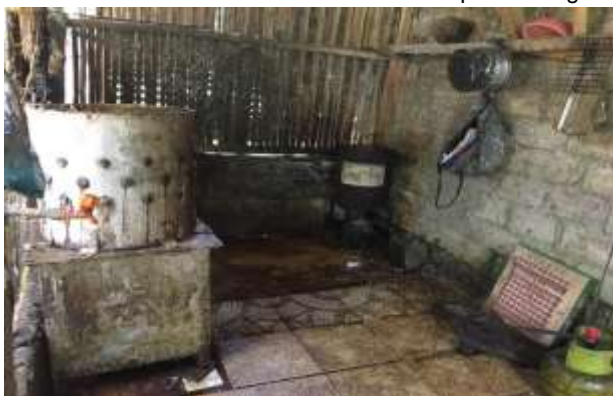
Figure 1. Construction of Chicken Slaughterhouses in Jampang Village

According to SNI 01-6160-1999, the layout must be designed so that it is in line with the process flow and has sufficient space so that all poultry slaughtering activities can run well and hygienically. The size of the room must also be adjusted to the cutting capacity. There are no clear boundaries between dirty and clean areas. So that workers are free to enter clean and dirty areas. This will cause cross-contamination through the skin, rumen fluids, blood, and labor of the carcass. So that the carcass produced and marketed becomes unsafe and unhealthy for consumption (Rohyati, 2017). A picture of the production room of a chicken slaughterhouse in Jampang Village can be seen in Figure 1. The chicken slaughterhouse building does not meet the requirements for walls and floors, as can be seen in Figure 1. This requirement is not fulfilled, among others, because there is a wall made of brick which is only roughened, without any more layers so that the material is not waterproof and has the potential to grow moss around the walls.

Proposed improvements to the Chicken Slaughterhouse in Jampan Village based on SNI 01-6160-1999 include: routine health

checks, standard equipment must be met, sanitary buildings made separate from living quarters. In addition, spatial planning is improved in the direction of the process flow, there is a clear physical separation between clean and dirty areas. Walls and floors in buildings must be designed to be waterproof, not easily corrosive. The building construction is made rodent-free and disinfected every two weeks to maintain cleanliness. The completeness of the building must have an employee rest area, a place for storing personal items, and generating sets. Sanitation facilities must be fulfilled, one of which is a means of washing hands and providing soap, a cloth / hand drier as a hand dryer. Carcass tools can be replaced with tools made from stainless steel. The carcass must also be cleaned using detergent every day. The chicken coop should be cleaned and washed regularly. The carcass is placed on a waterproof mat and not the cutting floor, the chicken carcass should be temporarily stored in a closed container after which it is burned.

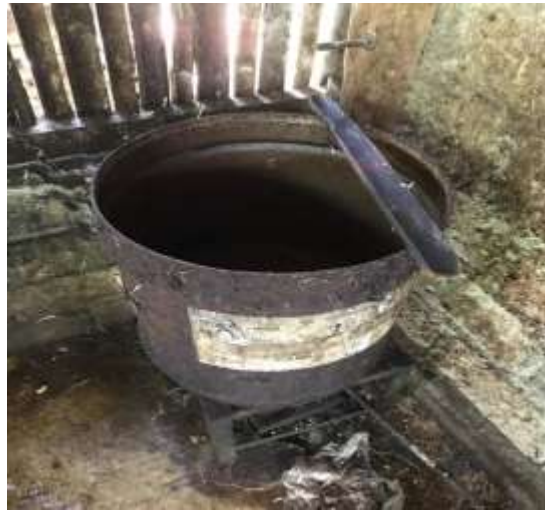
Figure 2. Equipment for a Chicken Slaughterhouse Dipping Pot in Jampang Village

Table 12 shows that the pot utensils used are corroded. The pot that is used is washed every day. Pans used but never washed using detergent. This condition can cause microbes to contaminate broiler chickens such as salmonella (Aerita *et al.*, 2014). The pan equipment used can be seen in Figure 2.

According to SNI 01-6160-1999, equipment that is directly related to meat must be made of non-toxic, non-corrosive, easy to clean and densified and easy to care for.

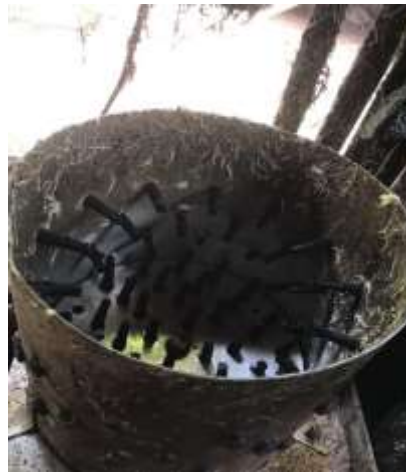
Figure 3. Feather removal tool for a chicken slaughterhouse in Jampang village

Table 13 shows that the hair removal tool used is corroded. Feather pluckers used in chicken slaughterhouses are washed every day. Hair removal tools that are used but never washed

Table 13 shows that the hair removal tool used in chicken slaughterhouses can be seen in Figure 3. The hair removal tool used in
